# Manhole Inspection Summary

Manhole # S21GG\_056MH

Insp Date: **6/19/07 12:03 PM**

**Location** Address: **1500 MOUNTMOR CT**

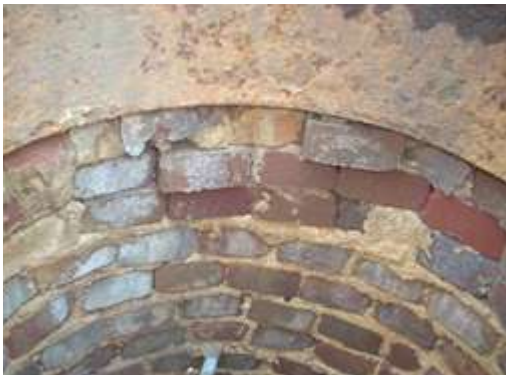
Defect 2

Condition: ☐ Sound ☒ **Cracked** ☐ Root Intrusion ☒ **Loose Brick** ☐ Deteriorated

LOOSE CHIMNEY BRICKS

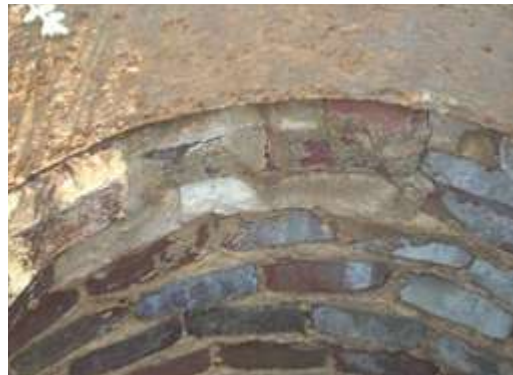
Defect 3

CRACKED CHIMNEY

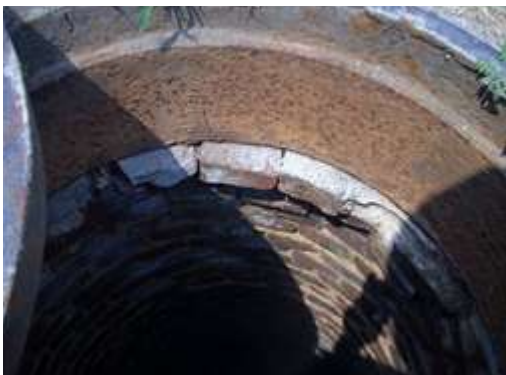
Defect 1

**Frame** Offset: **1** (in.) Condition: ☒ Sound ☐ Cracked ☐ Leaks

FRAME OFFSET

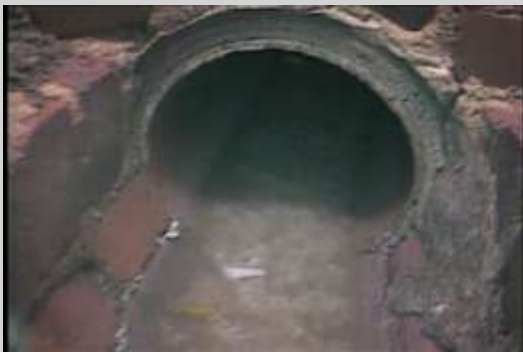
12 O'Clock Outflow

Pipe Height: **8.4** (in.) Rod and Bar (Angled)  
Pipe Material: **Clay** ☐ Pipe Lined  
Invert Depth: **9.82** (ft.) Flow Characteristics: **Slow**  
Deposits: ☐ None ☐ Mud ☐ Sludge ☒ **Debris** ☐ Grease  
Silt Depth: **1** (in.) Deposits Extent: **Light**  
Infiltration: **None** Pipe Seal Cond: **Sound**

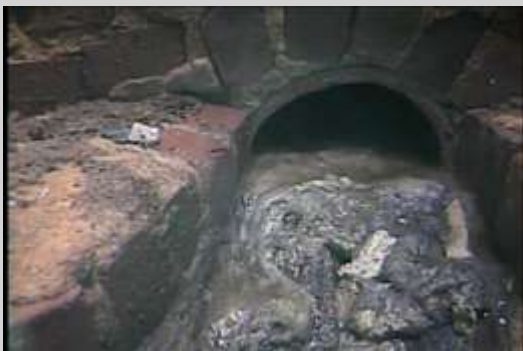
3 O'Clock Inflow

Comments **ALOT OF DEBRIS IN CHANNEL OF I3**

DEBRIS

Pipe Height: **8.4** (in.) Rod and Bar (Angled)  
Pipe Material: **Clay** ☐ Pipe Lined  
Invert Depth: **9.71** (ft.) Flow Characteristics: **Slow**  
Deposits: ☐ None ☐ Mud ☐ Sludge ☒ **Debris** ☐ Grease  
Silt Depth: **6** (in.) Deposits Extent: **Heavy**  
Infiltration: **None** Pipe Seal Cond: **Sound**
